RE: 14 Perkins Avenue

PLAN OF LAND
IN
HAMPTON, NH

SHOWING
A EXISTING DWELLING
AT
14 PERKINS AVENUE

Subject Photo Page

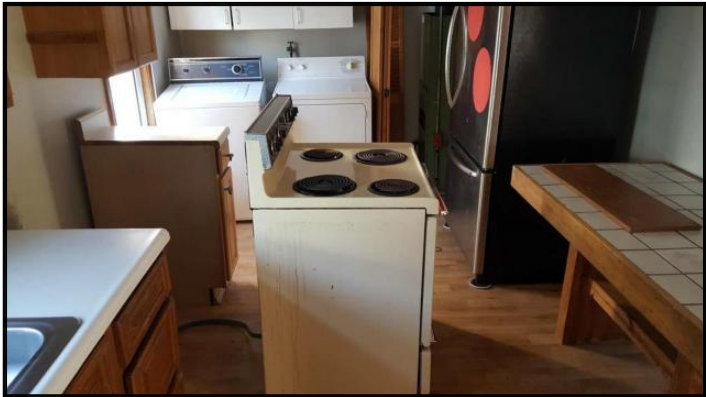
Kitchen
Dated

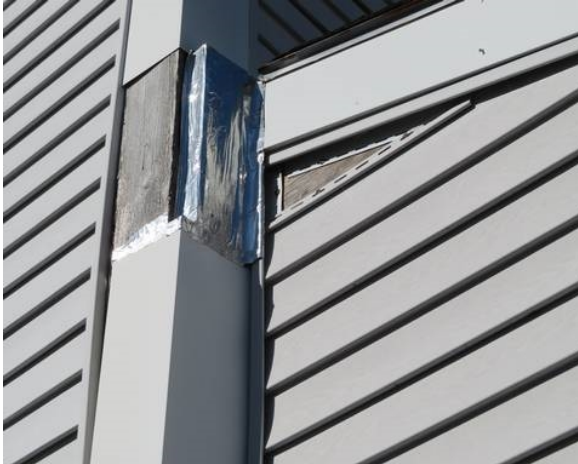
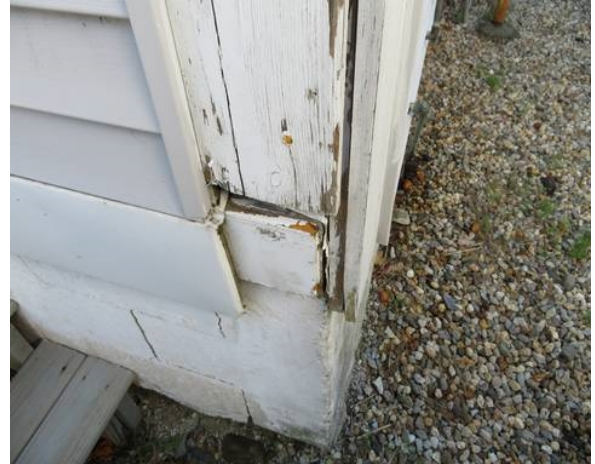
The wood siding (mostly on the front of the home) is showing signs of age and wear. Sections/pieces have been replaced due to deterioration / "cupping" of clapboard. Deterioration / cracking observed on other sections. Monitor the siding frequently and repair / replace as required to promote intended weathering protection to the internal structure.

Vinyl siding is considered to be a low maintenance siding relative to other materials and types, however it is prone to occasional damages and may require adjustments to keep it secure to the home and to prevent buckling. Periodically inspect the siding components, and consult with a siding professional to repair, or replace components as required to promote intended weather protection. Periodic cleaning / pressure

washing is required to maintain its appealing look and promote longevity of service. It is recommended to consult with the Seller to obtain spare / extra siding components, if available.

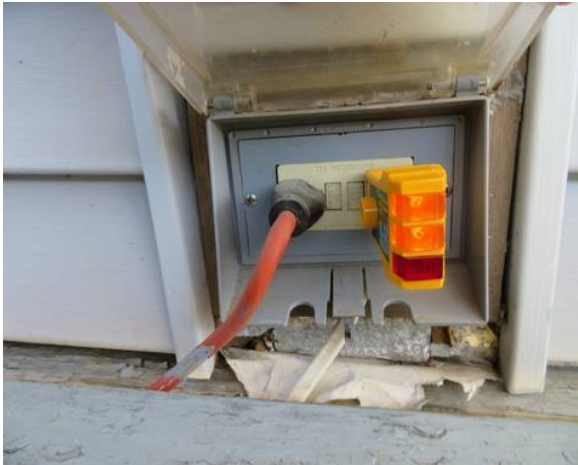
The GFCI receptacle did not function when tested. Consult with a qualified electrician to repair, or replace the unit.

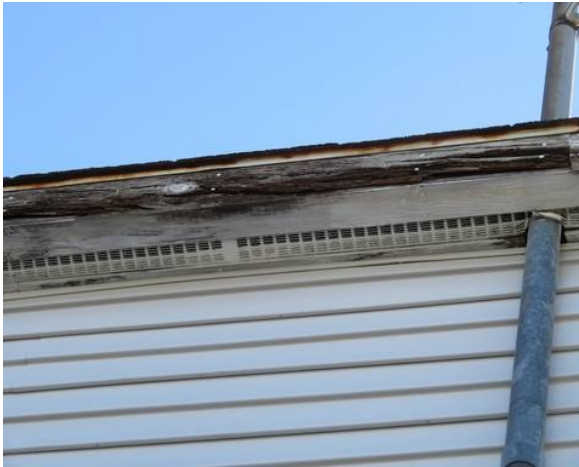
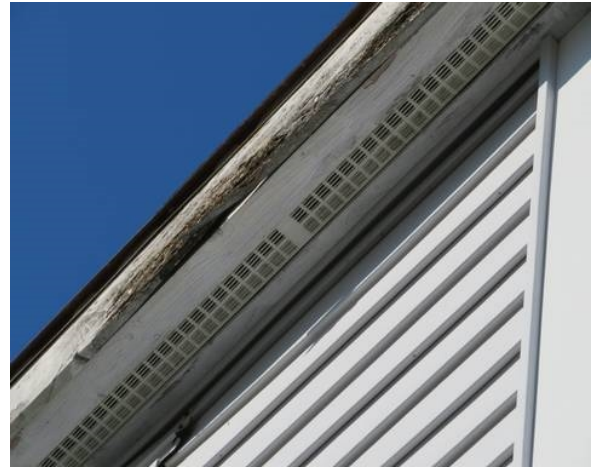
Rot, deterioration, peeling/chipped paint observed in several sections of fascia/soffit and base trim. Work with a qualified General Contractor to asses entire home and replace and repaint as required.

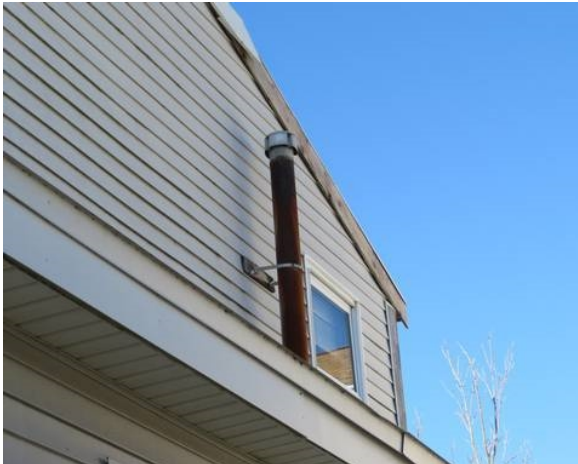
The clearance height requirement of the chimney from the roof does not appear to be met. The height requirement is a minimum of 24 inches within a 10 ft radius of the roof. Consult with a chimney professional to assess and modify to meet current design and safety standards.

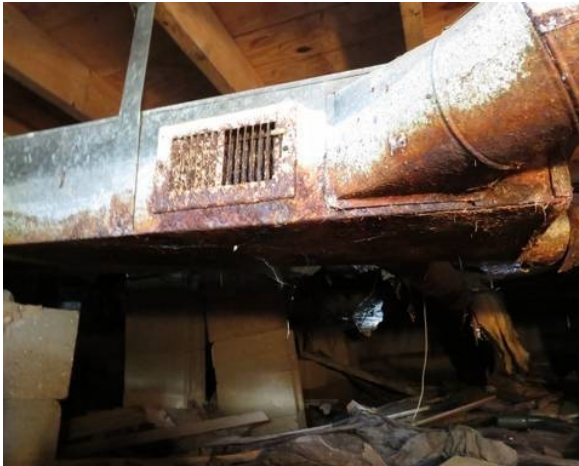
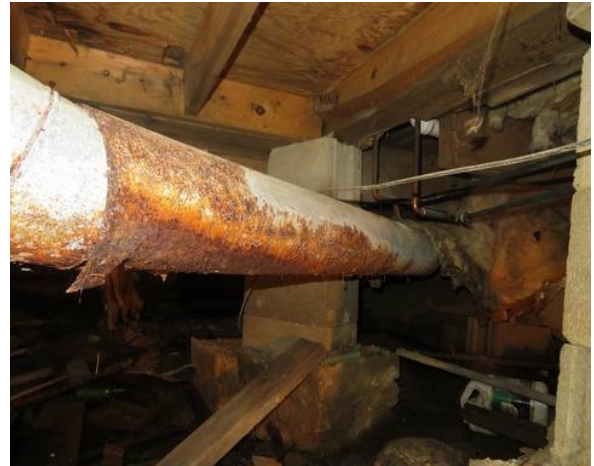
duct tape. Consult with a HVAC professional to properly support / seal the duct work.

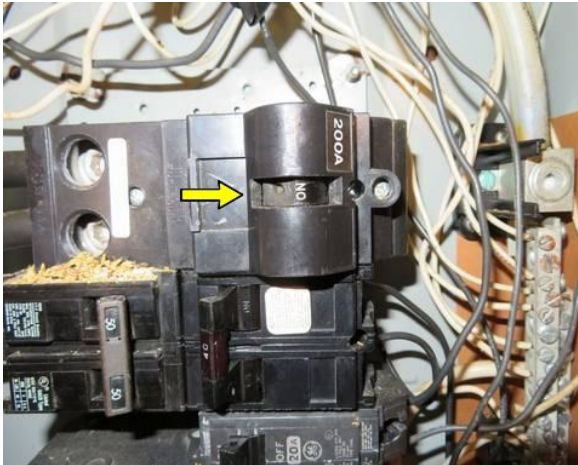
The toggle switch is broken on the main disconnect. Consult with an electrician to replace as required.

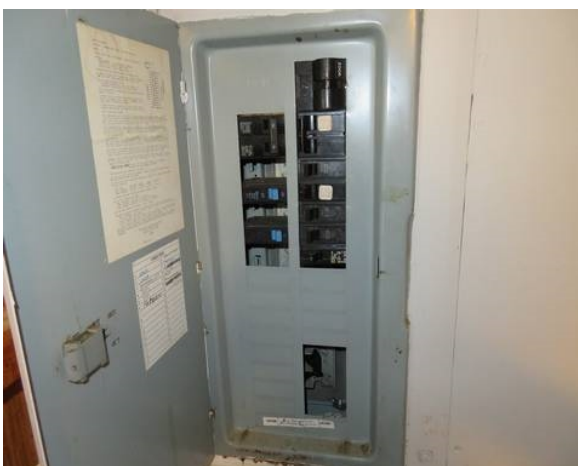
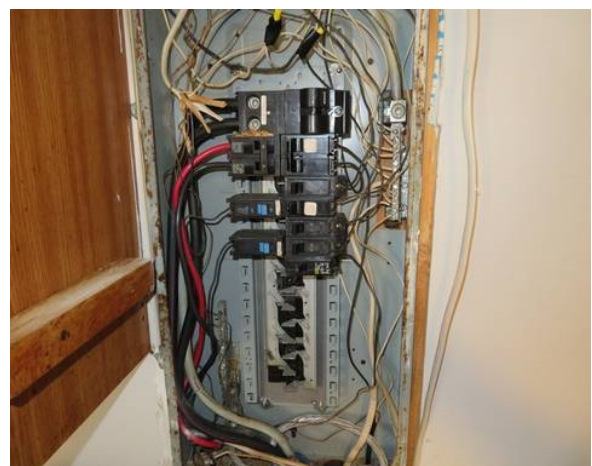
Pointed / sharp-ended screws are used to secure the panel cover. Consult with a qualified electrician to install the appropriate blunt nose bolts to properly secure the panel cover and prevent the accidental piercing of a circuit wire.

The stove is installed in front of the distribution panel, which prohibits readily available access. Acceptable practice requires a minimum of 3' in front of the panel for proper access and ventilation.

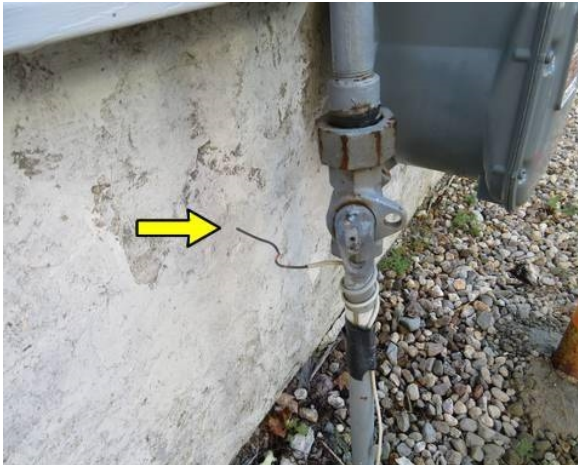
The electrical bonding for the gas piping was not determined. Consult with a qualified electrician, or pipe fitter, to assess and bond as required.

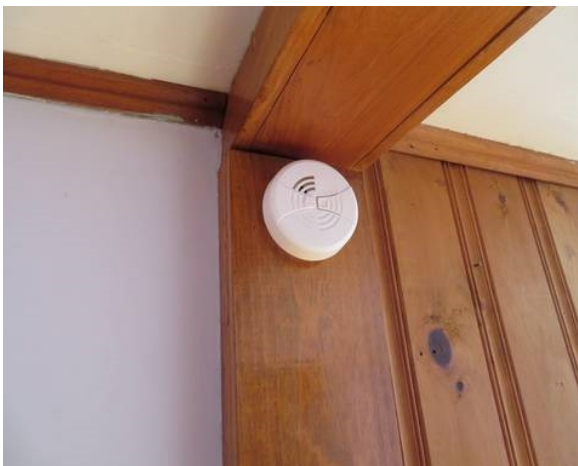
Smoke detectors have a useful life expectancy of 7-10 years. It is recommended to replace smoke detectors upon moving into the home, or obtain proof that they have been replaced recently. Check operation prior to moving into the home and on a monthly basis as an ongoing maintenance / safety check. Refer to the "Info Series" guidelines at the end of the report for recommended room placement and locations.

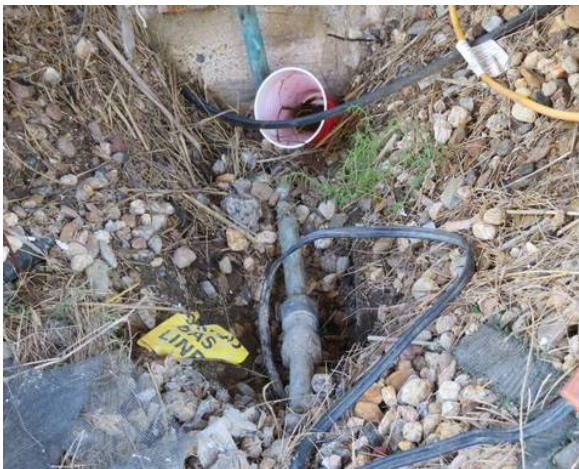
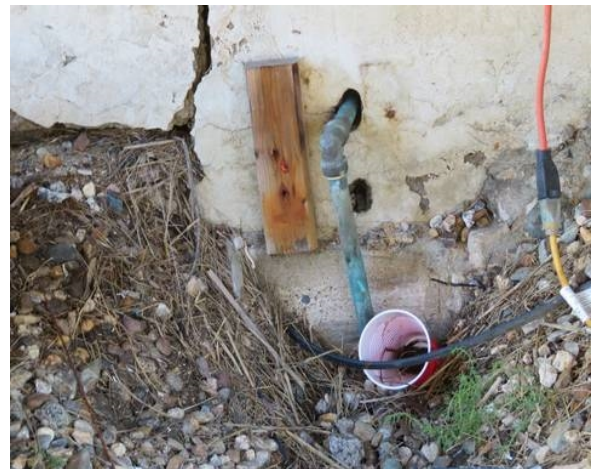
The main water line enters the home from the front side and under the deck area. Consult with a qualified plumber to confirm the presence of the proper insulation and / or heat tape to prevent freezing of the main line.

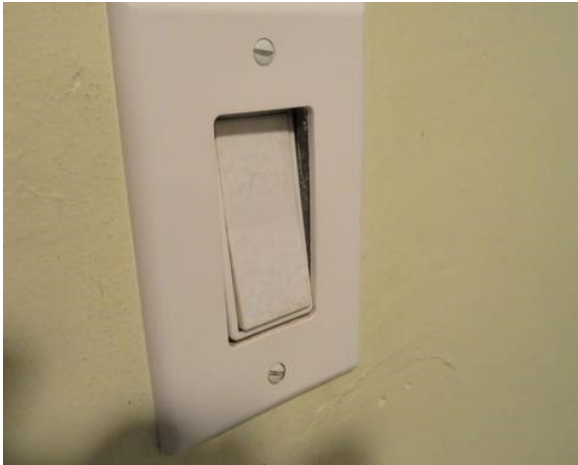
Switch plate does not sit flush against the wall. Consult with an electrician to evaluate and repair as required.

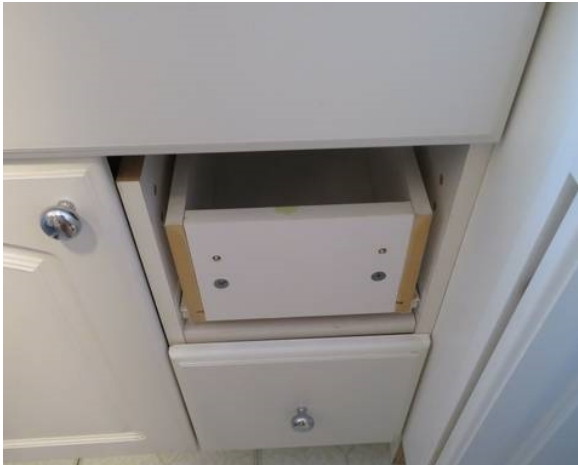
One of the drawer fronts is detached. Secure / supplement the hardware and fasteners to restore stability.

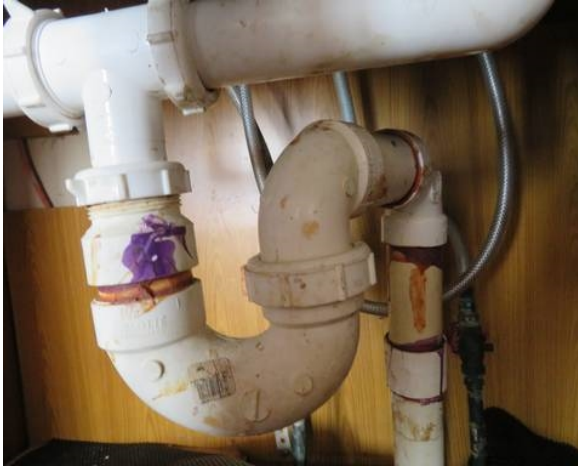
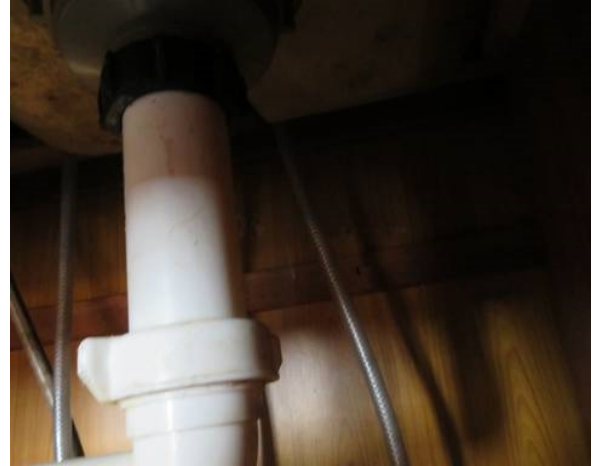
An "S" style trap is installed in lieu of a "P" trap, which could adversely affect its anti-siphoning and draining characteristics. Monitor for performance. Consult with a qualified plumber to install a mechanical vent as an optional improvement.

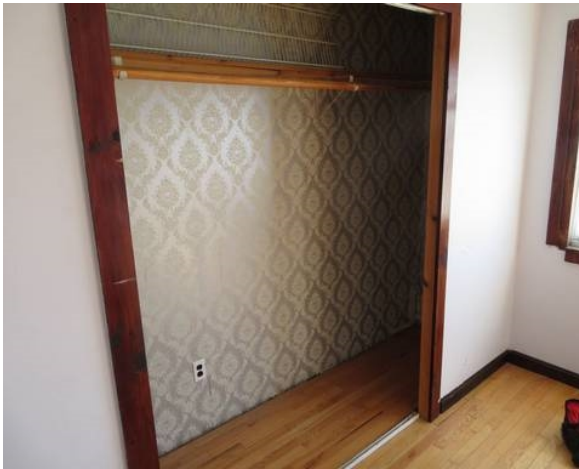
Replace missing closet doors as required.
